**REPORT NUMBER: 301-MGA-2009-010**

**SAFETY COMPLIANCE TESTING FOR FMVSS 301R  
FUEL SYSTEM INTEGRITY – REAR IMPACT**

**GENERAL MOTORS CORPORATION  
2008 CHEVROLET EXPRESS 2500 WORK VAN  
NHTSA NUMBER: C80114**

**PREPARED BY:  
MGA RESEARCH CORPORATION  
5000 WARREN ROAD  
BURLINGTON, WI 53105**

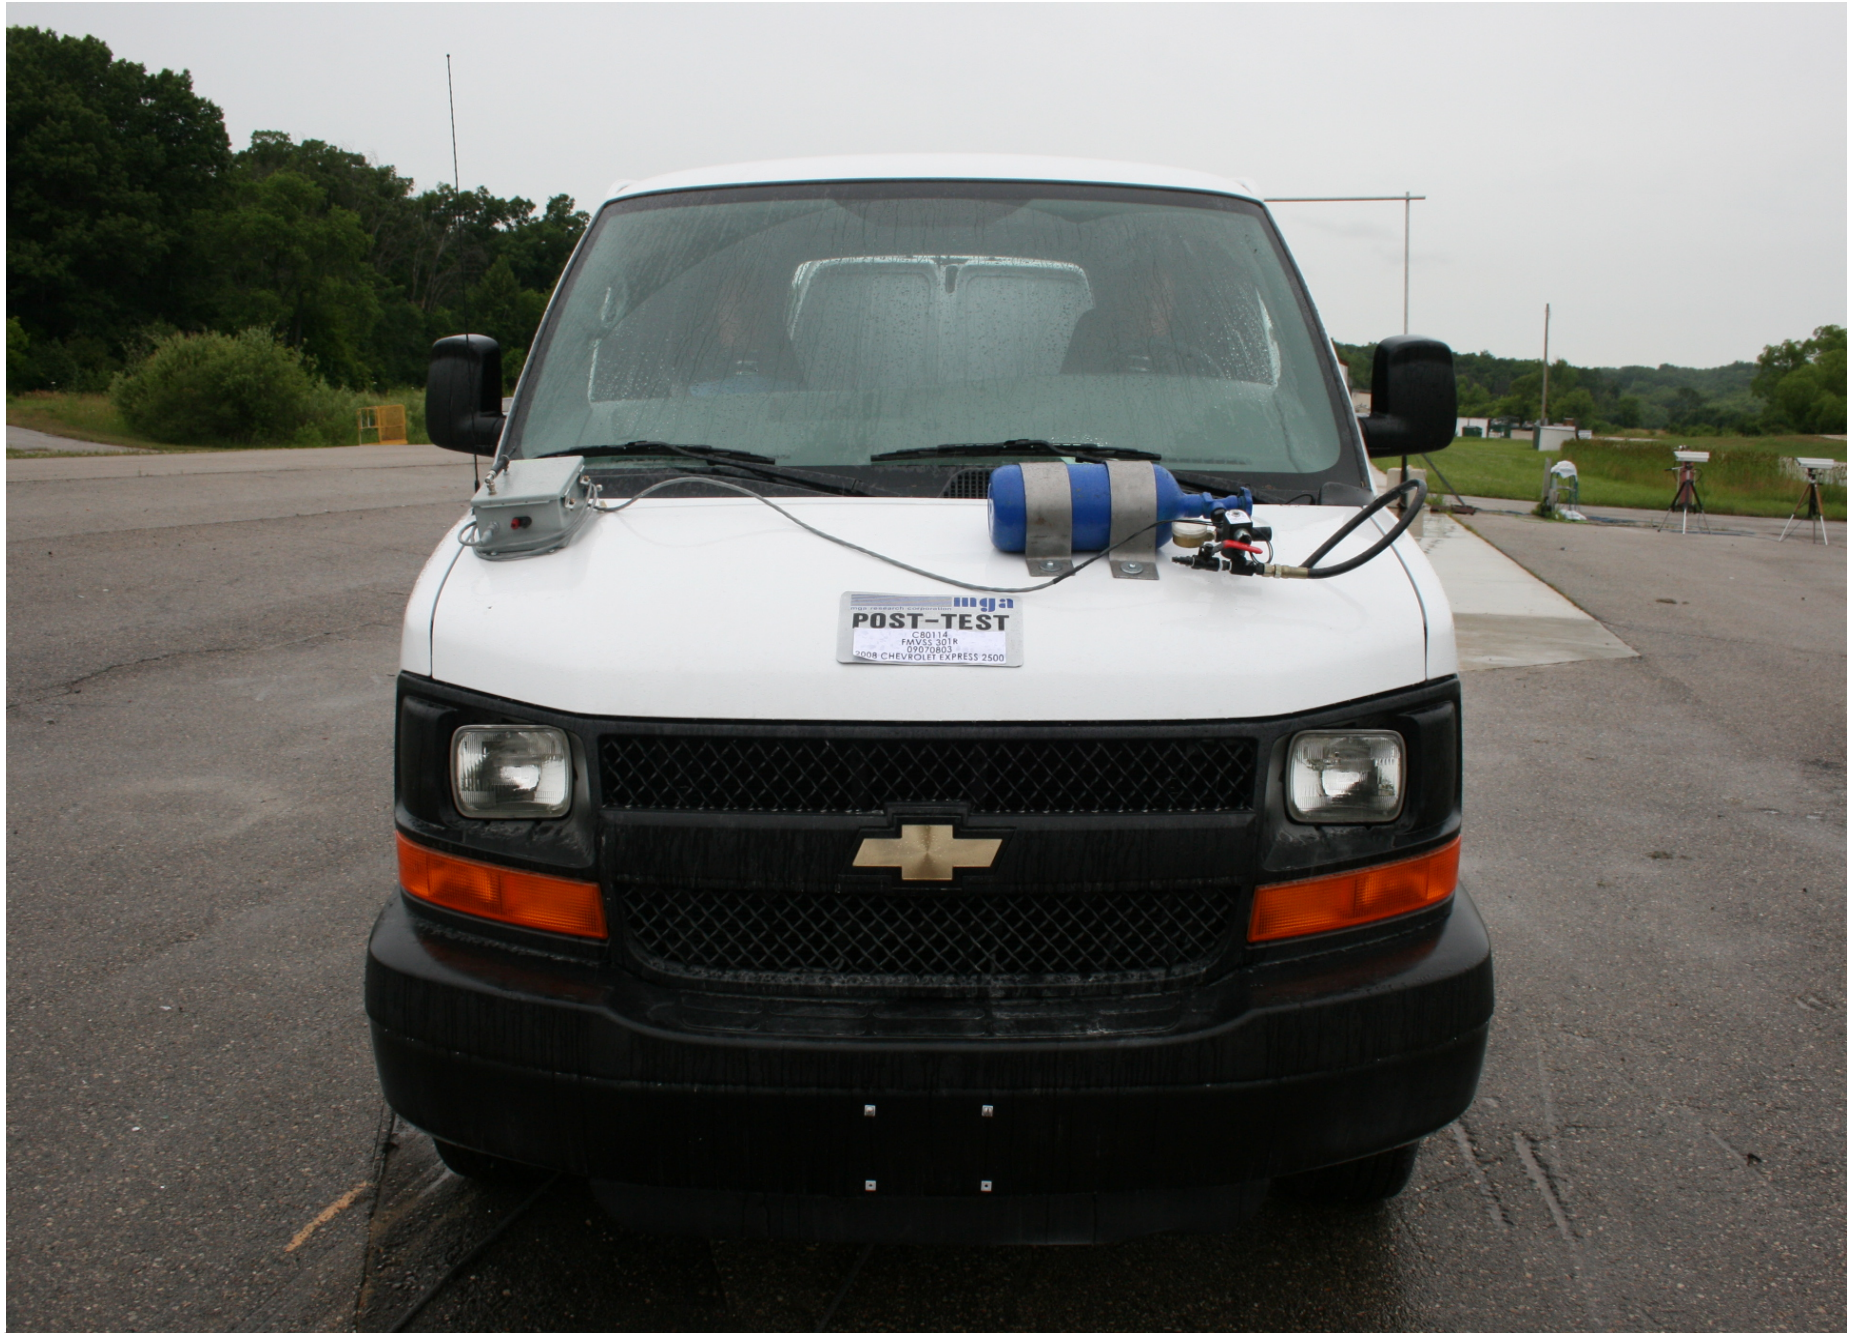
Post-Test Front View of Vehicle

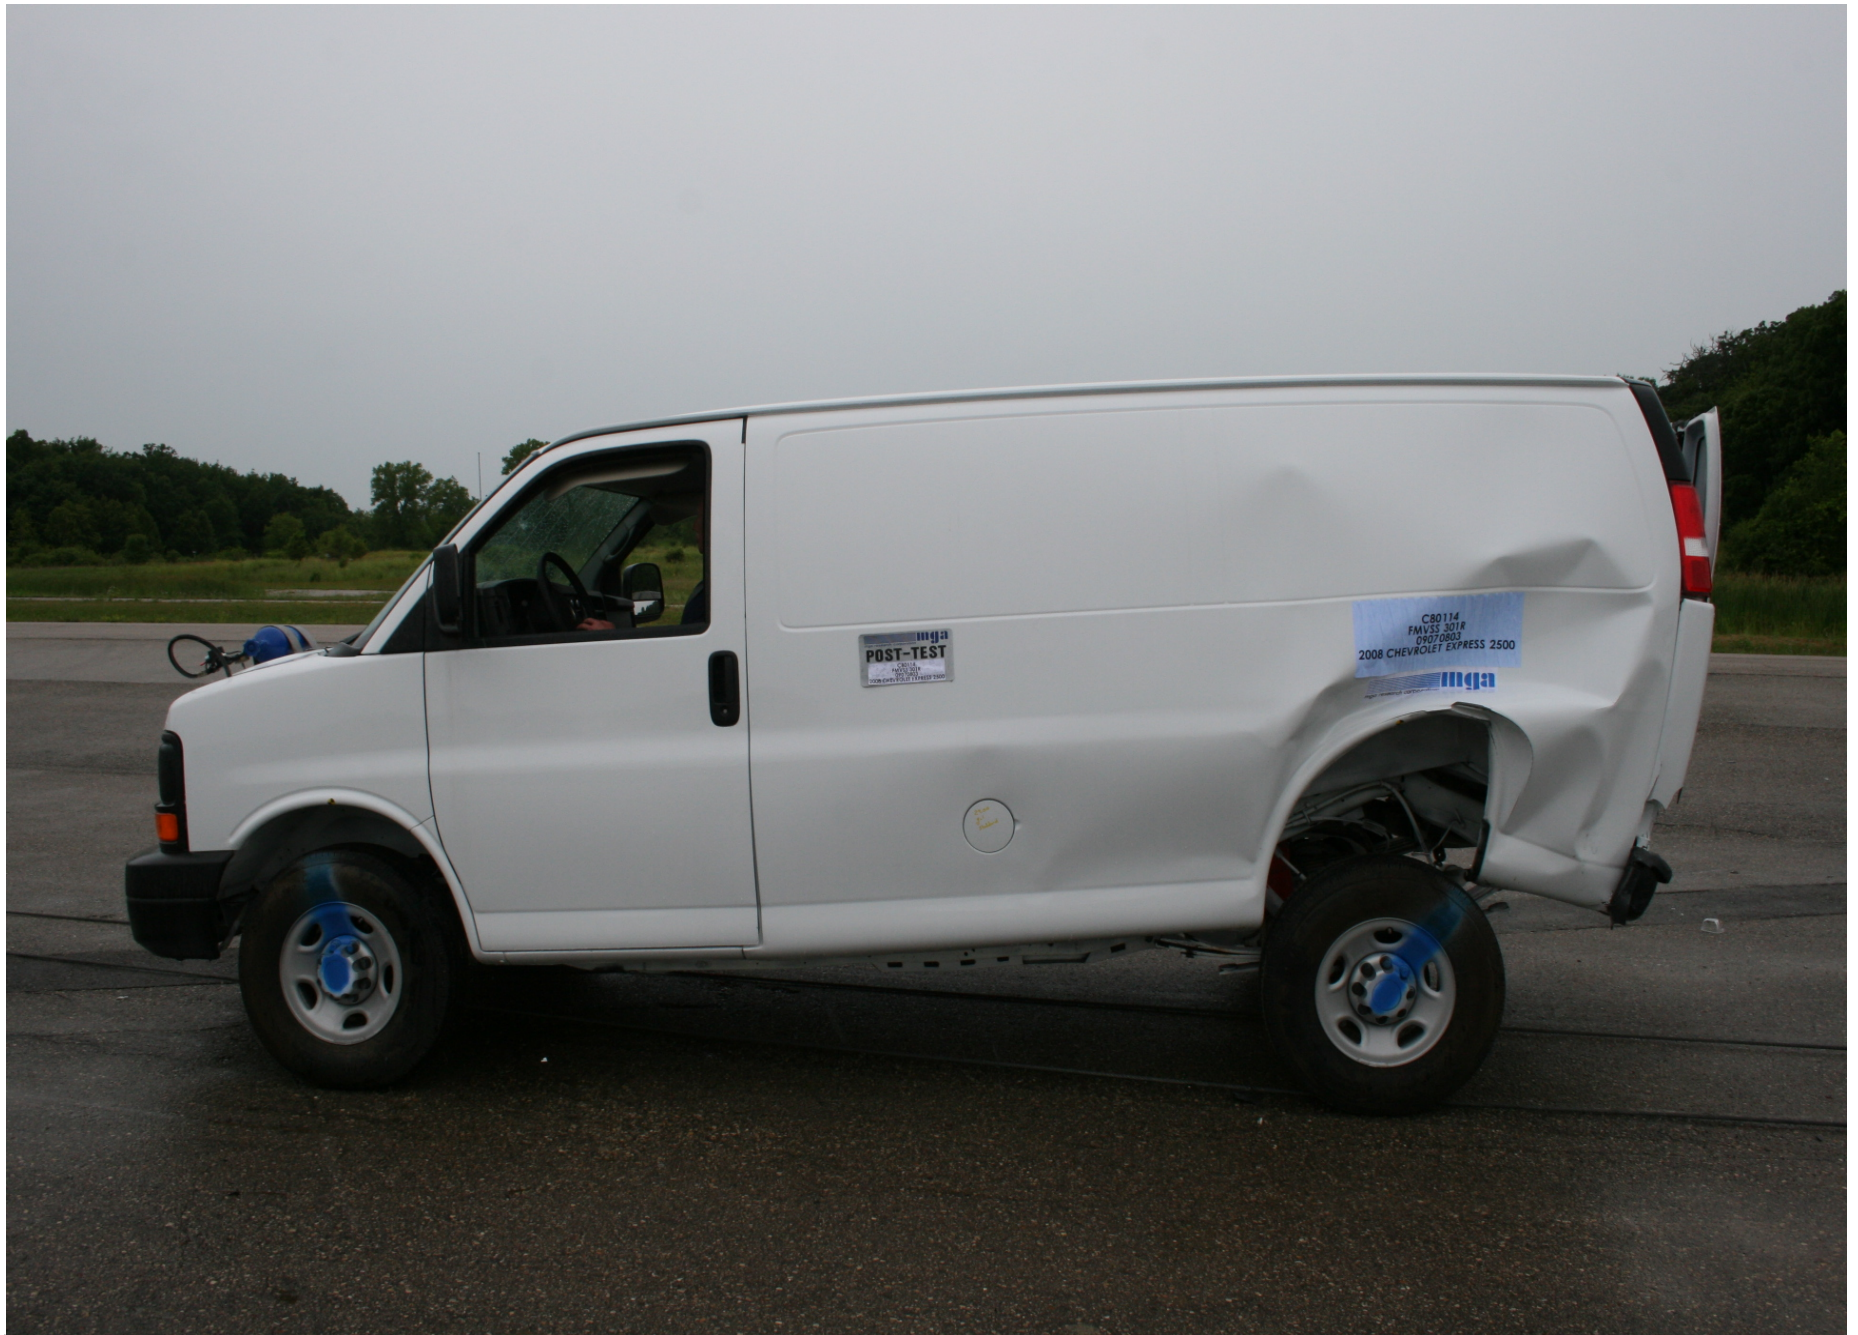
Post-Test Left Side View of Vehicle

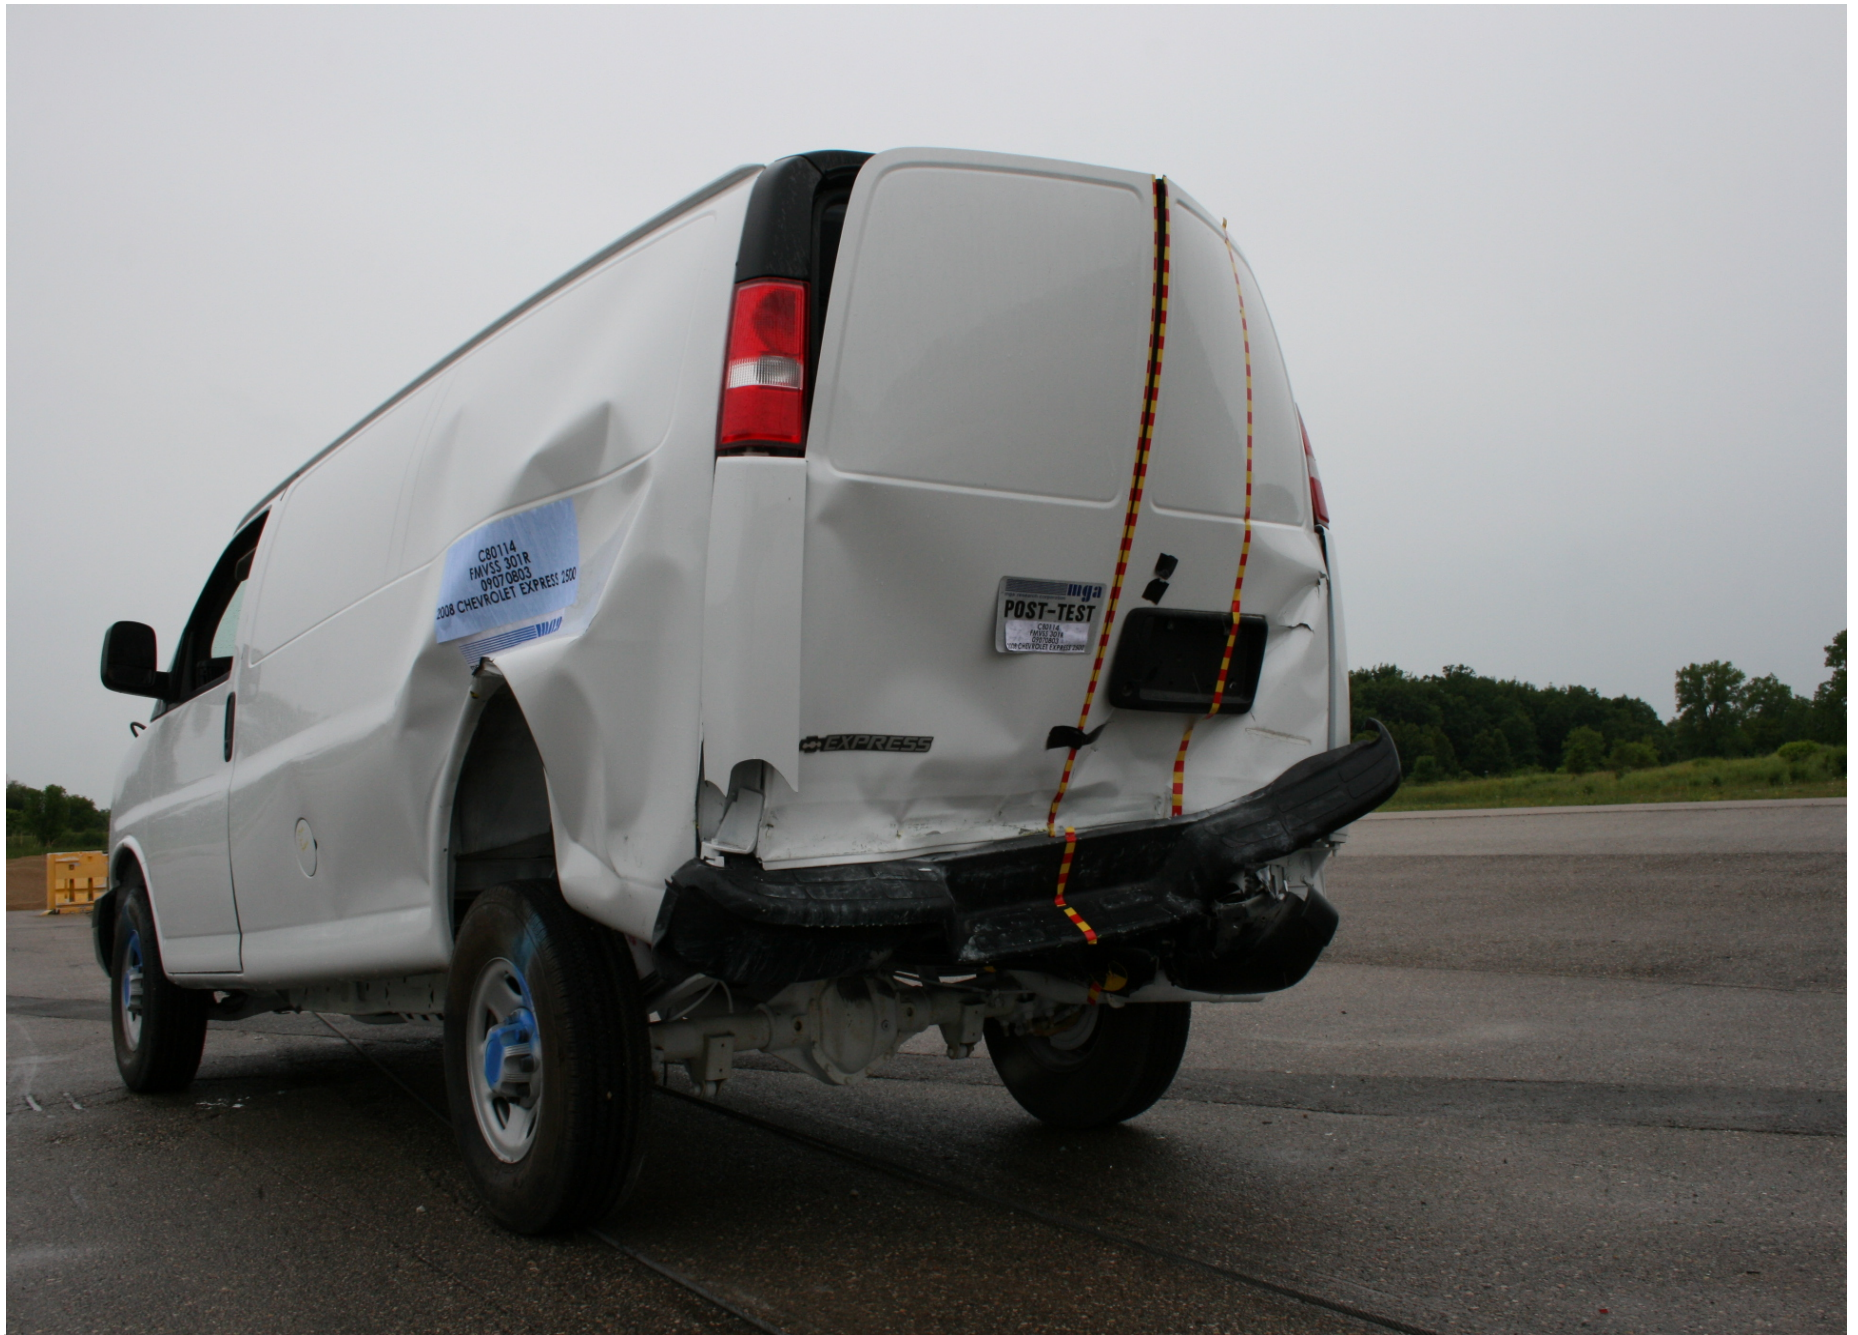
Post-Test Left Rear Close-up View of Vehicle

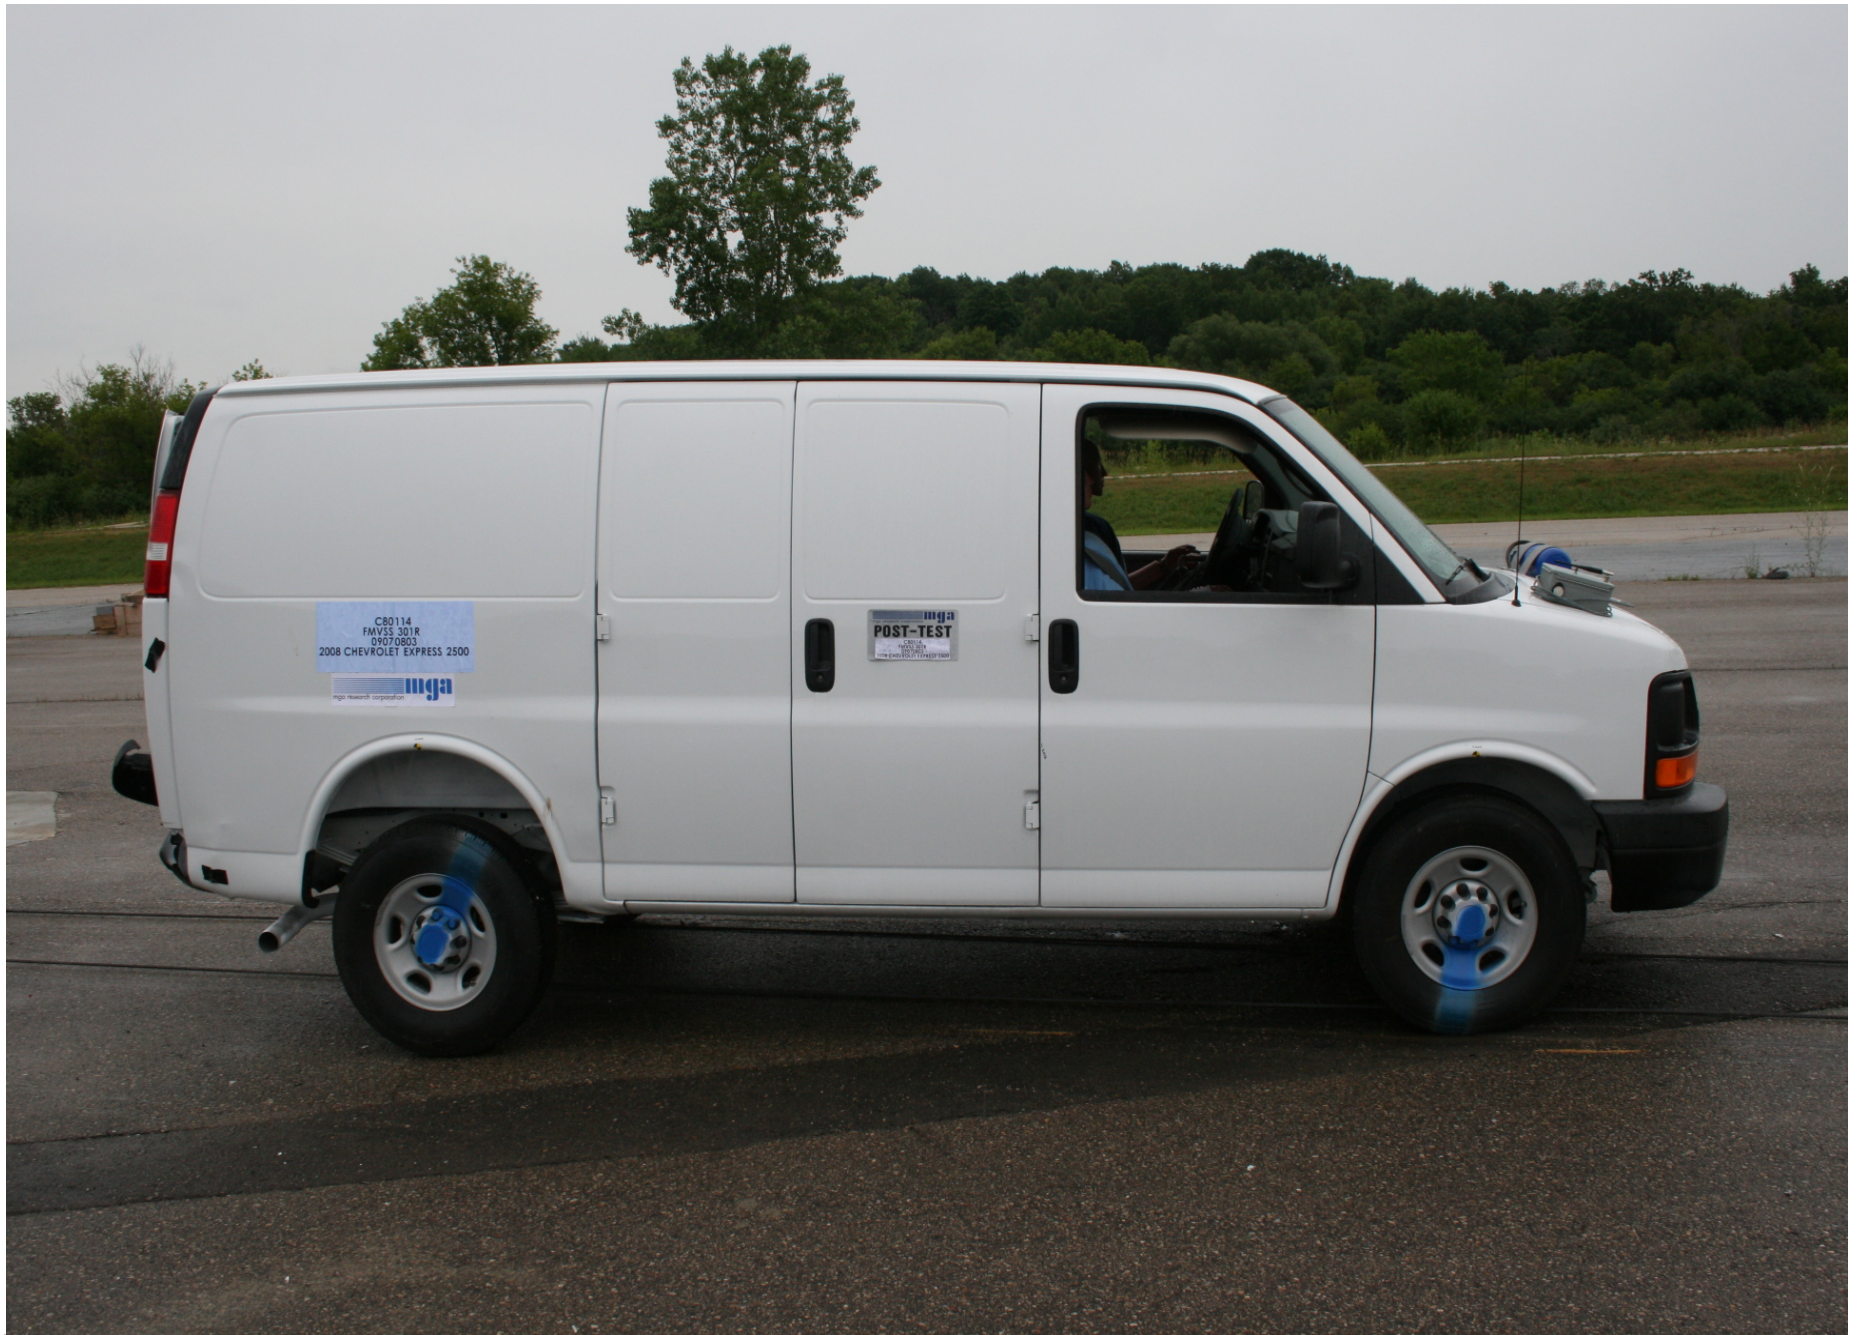
Post-Test Right Side View of Vehicle

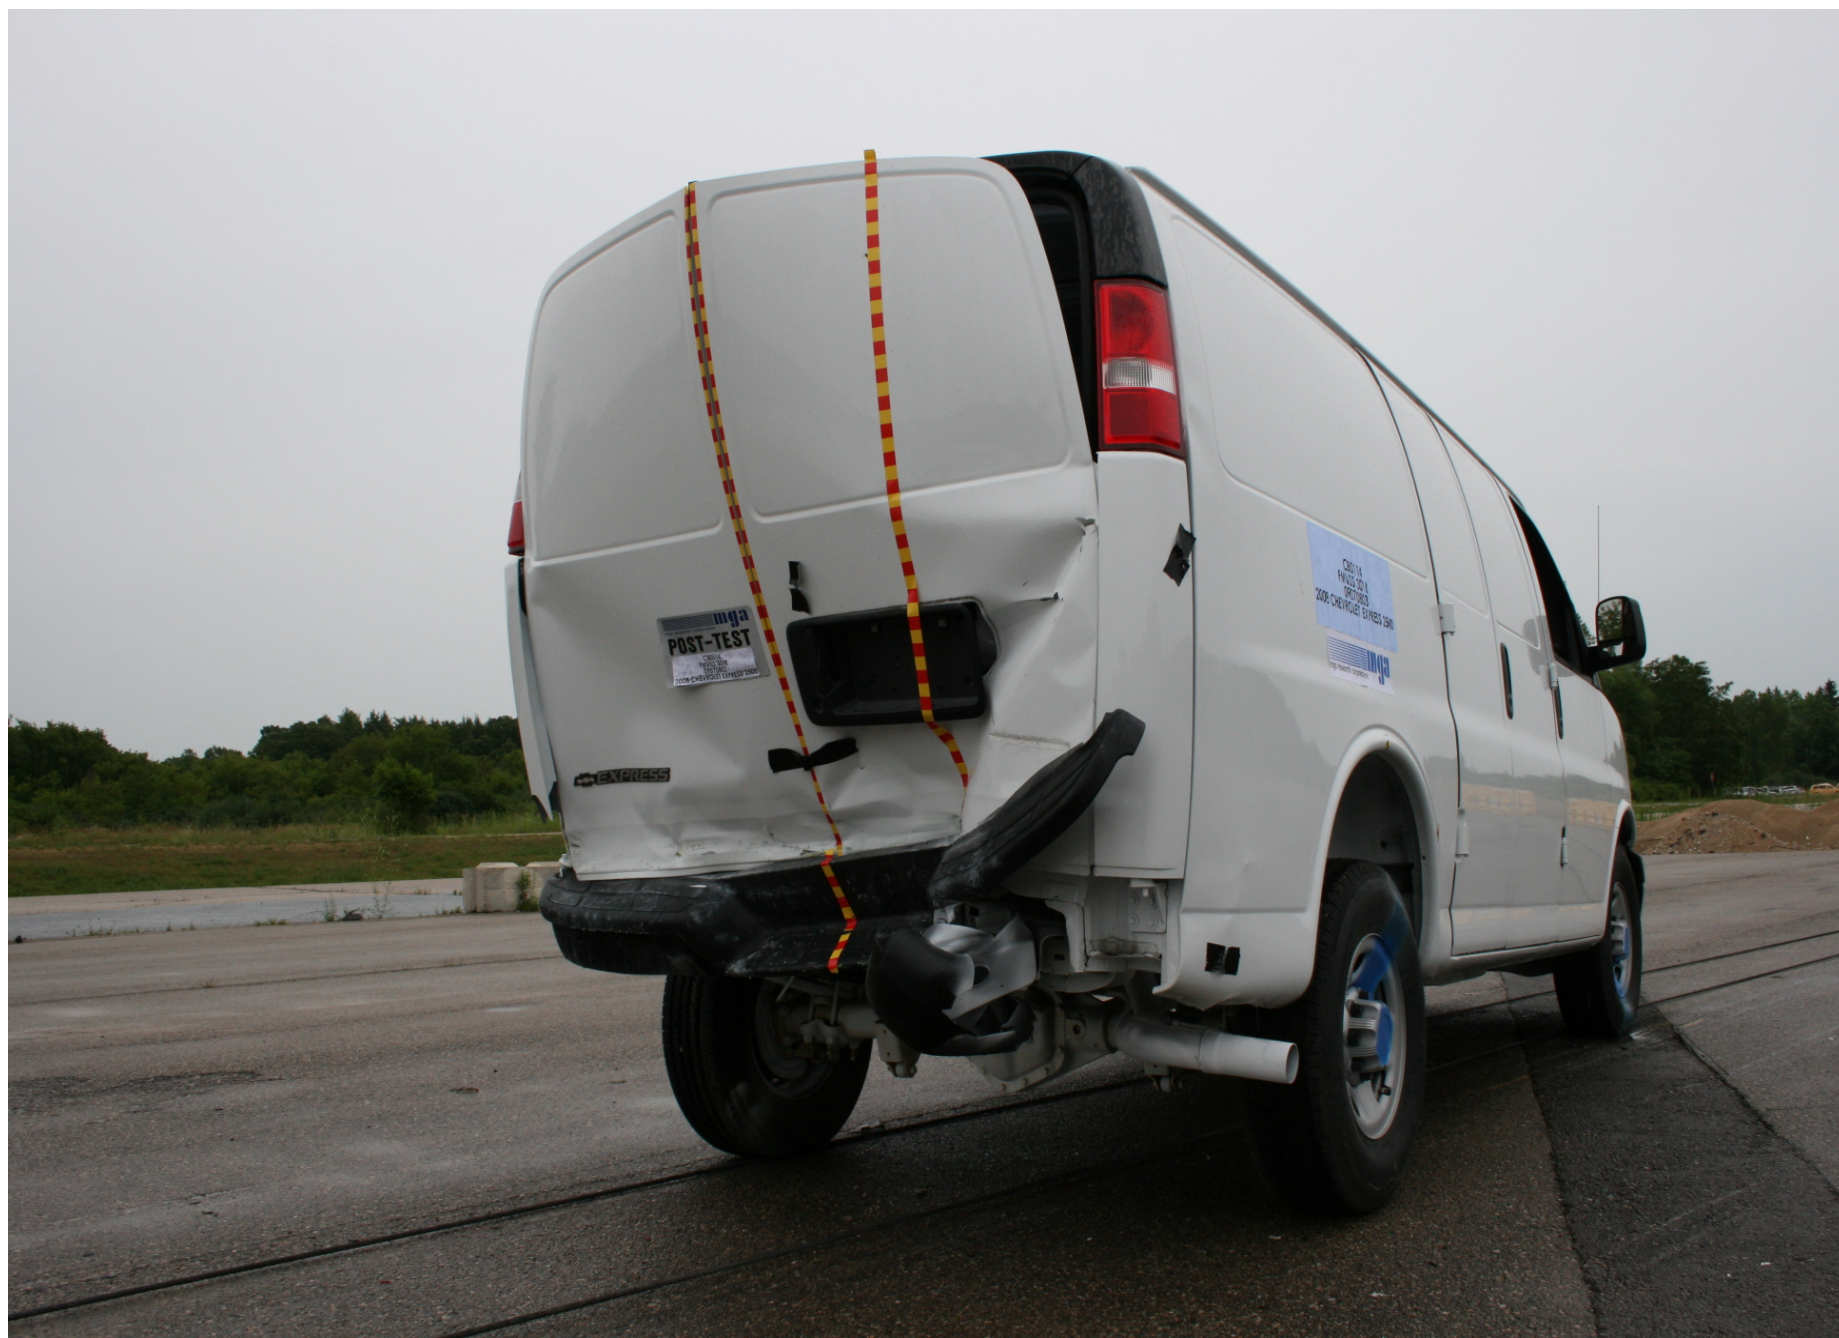
Post-Test Right Rear Close-up View of Vehicle

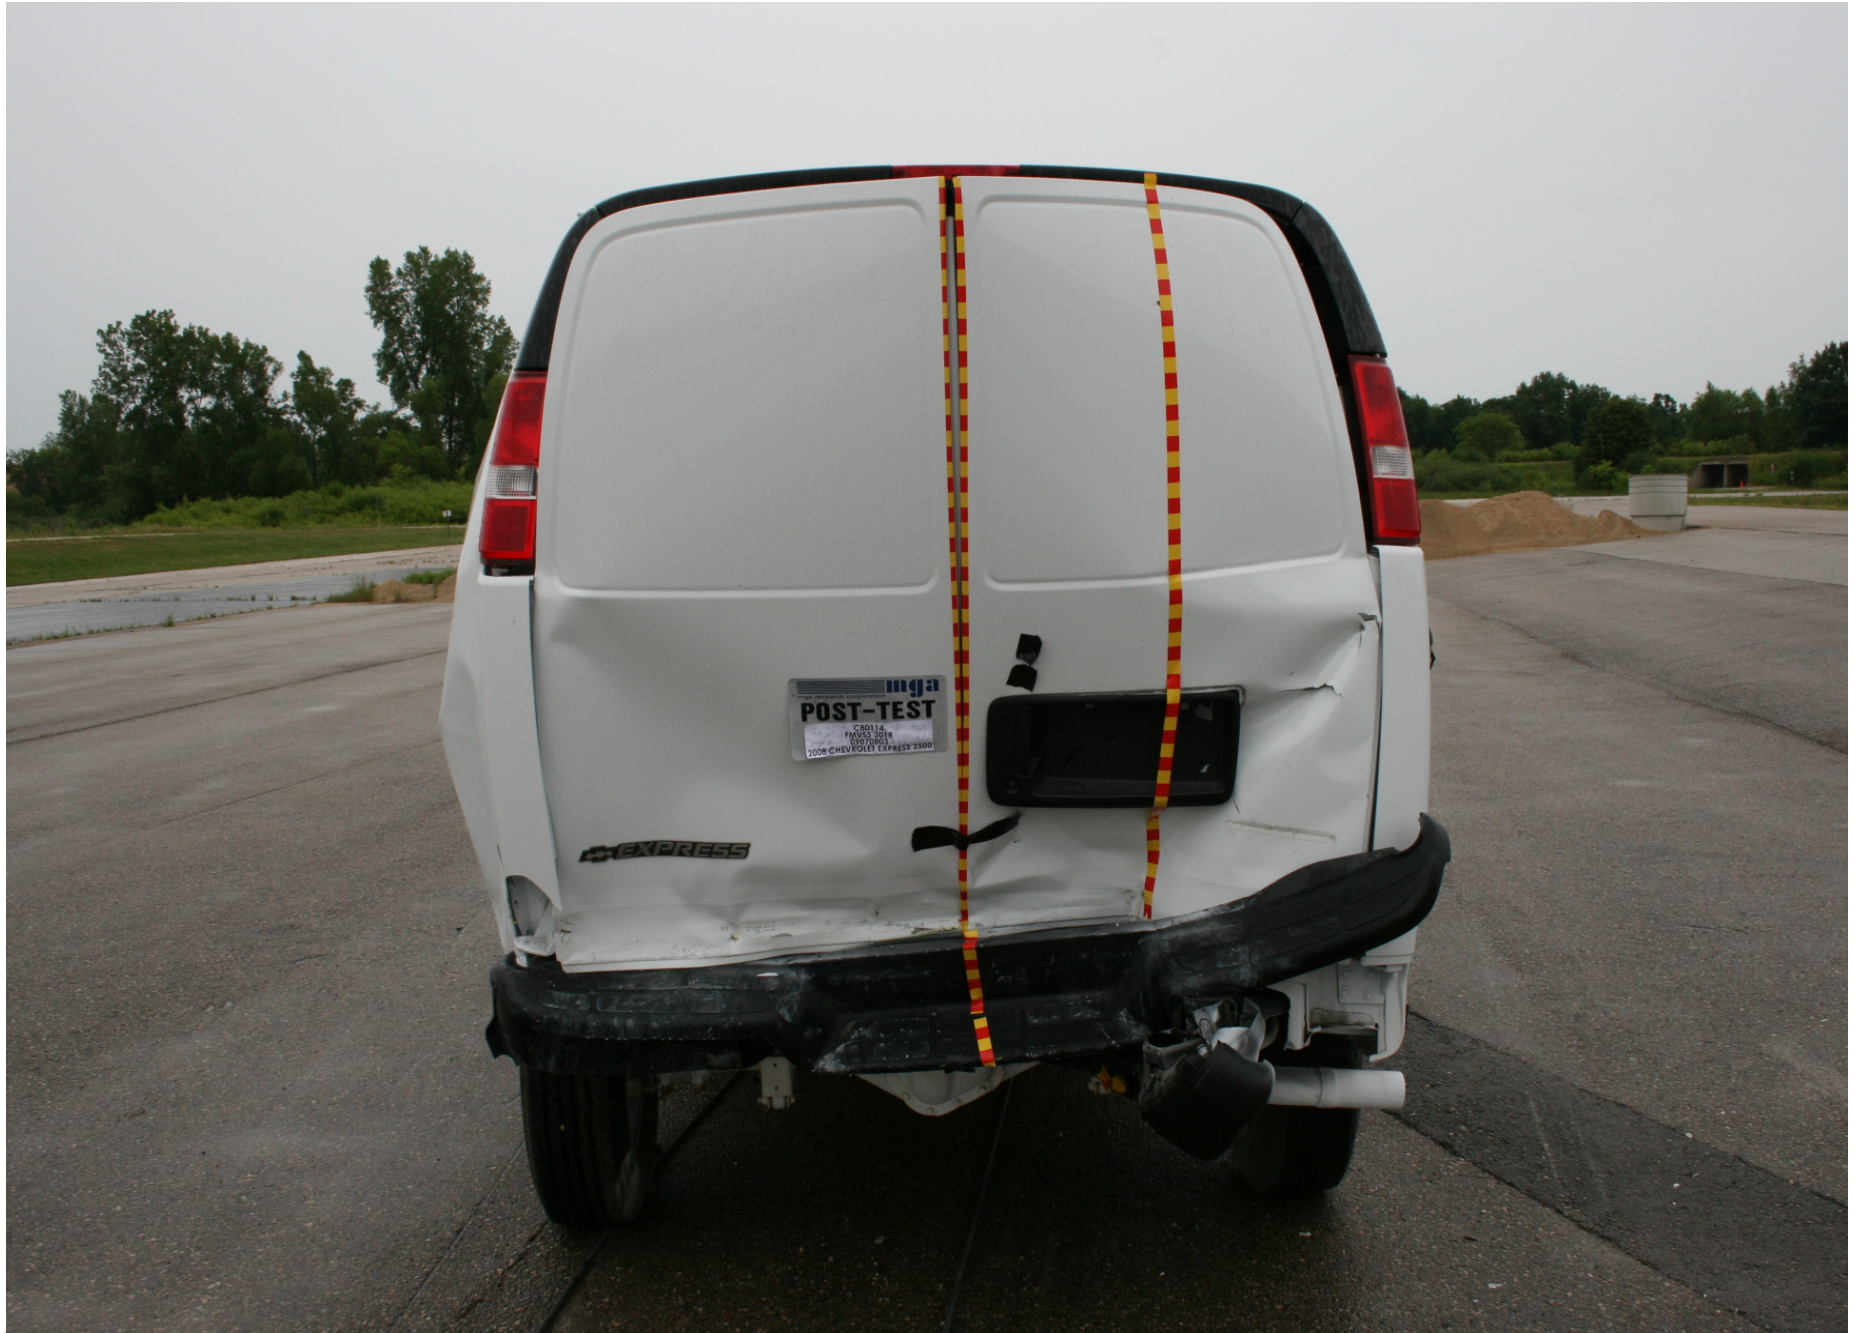
Post-Test Rear View of Vehicle

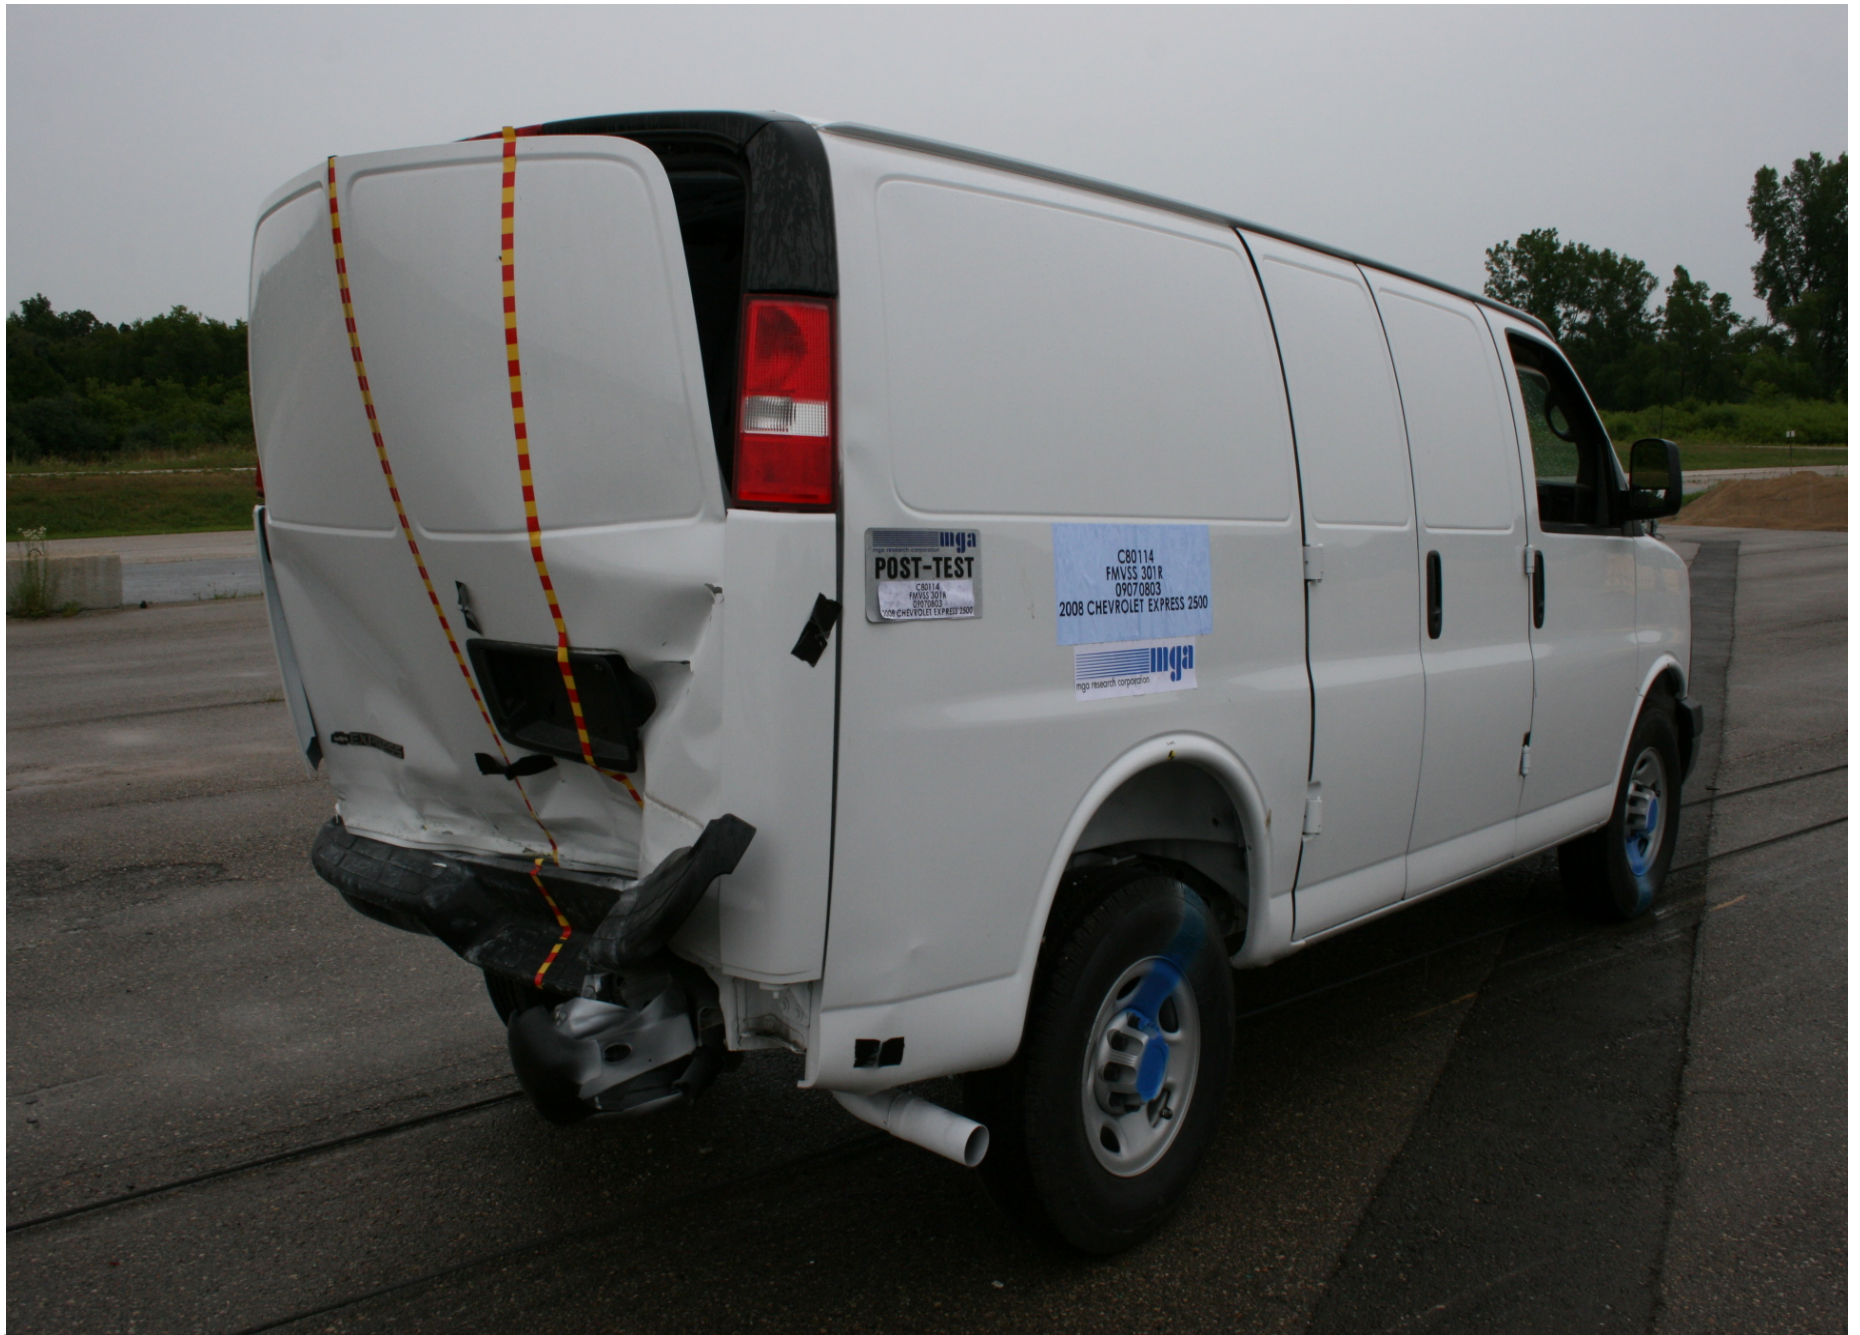
Post-Test  $\frac{3}{4}$  Rear View From Right Side of Vehicle

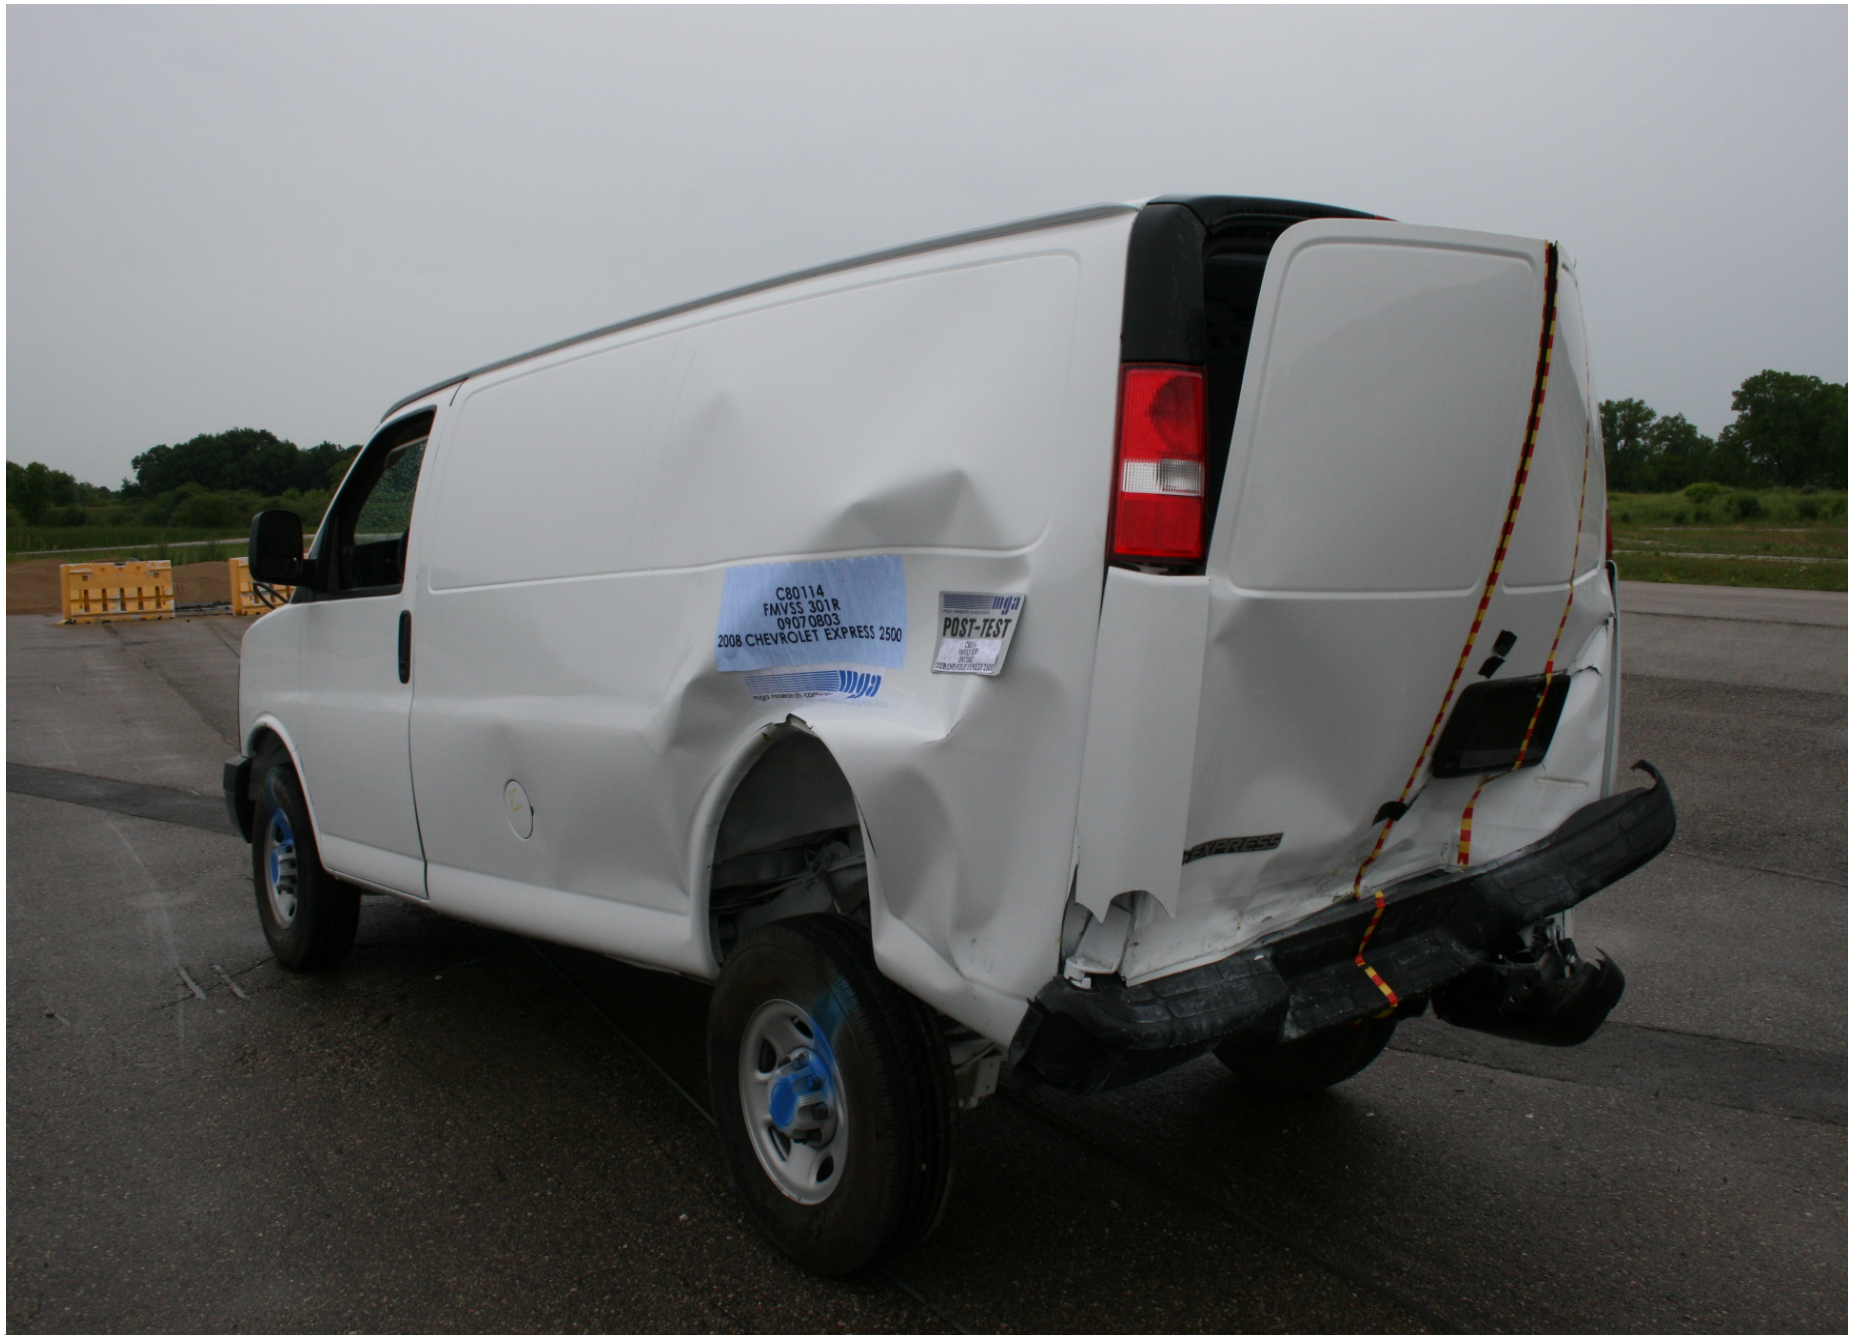
Post-Test ¾ Rear View From Left Side of Vehicle

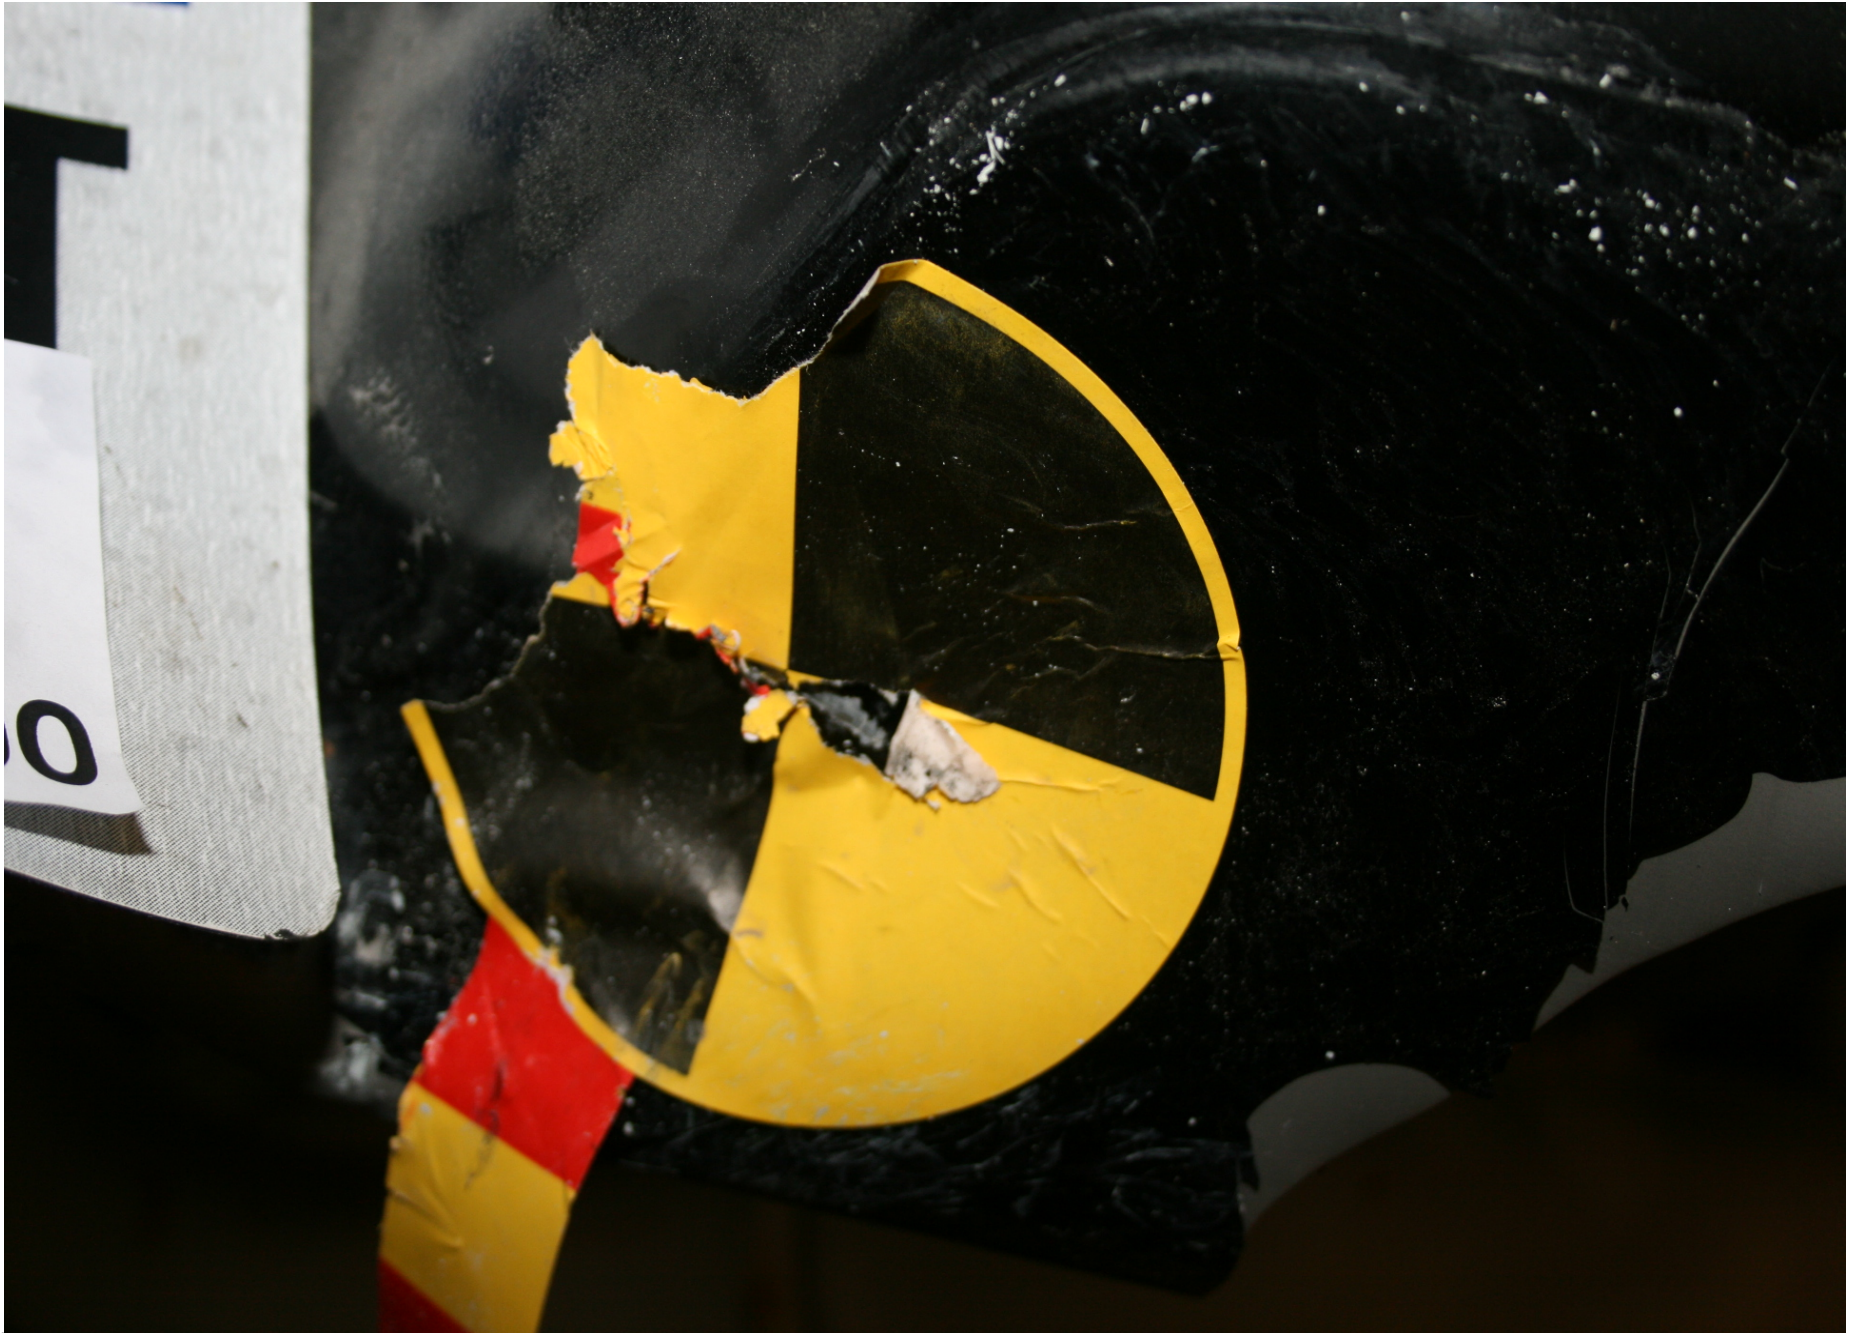
Post-Test Impact Point
